## **10 Types of Personal Injuries Seafarers Must Be Aware Of**

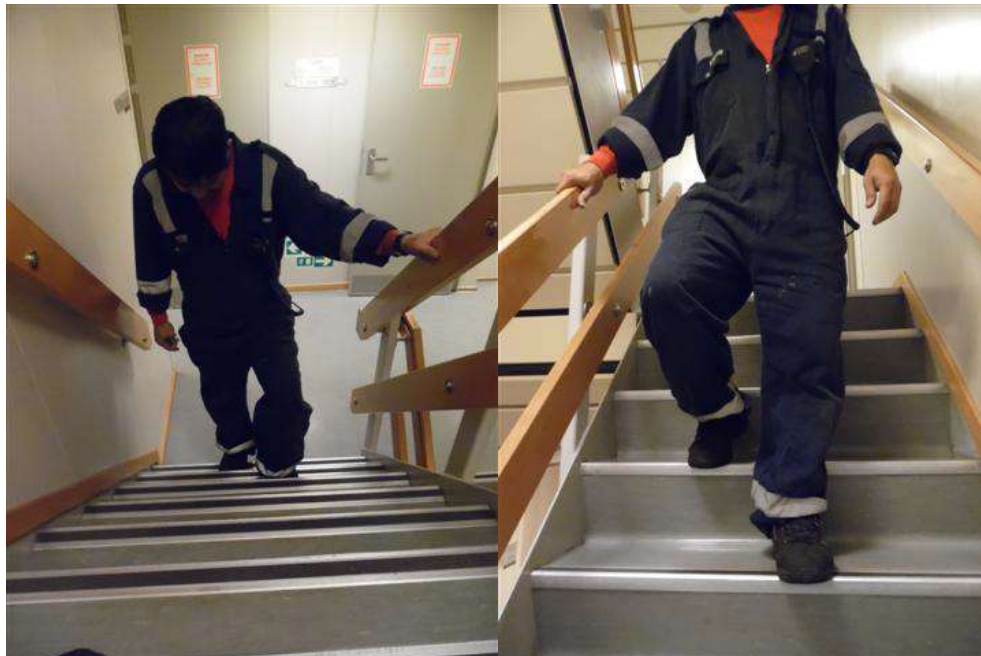
Correct way of going up and coming down the stairs.

- Walking on stairs is to be taken with the same approach to every other task we do on board, which is; focus.
- Take your time, there is no need to hurry.
- Maintain 3 points of contact at all times and look where you are placing your feet.

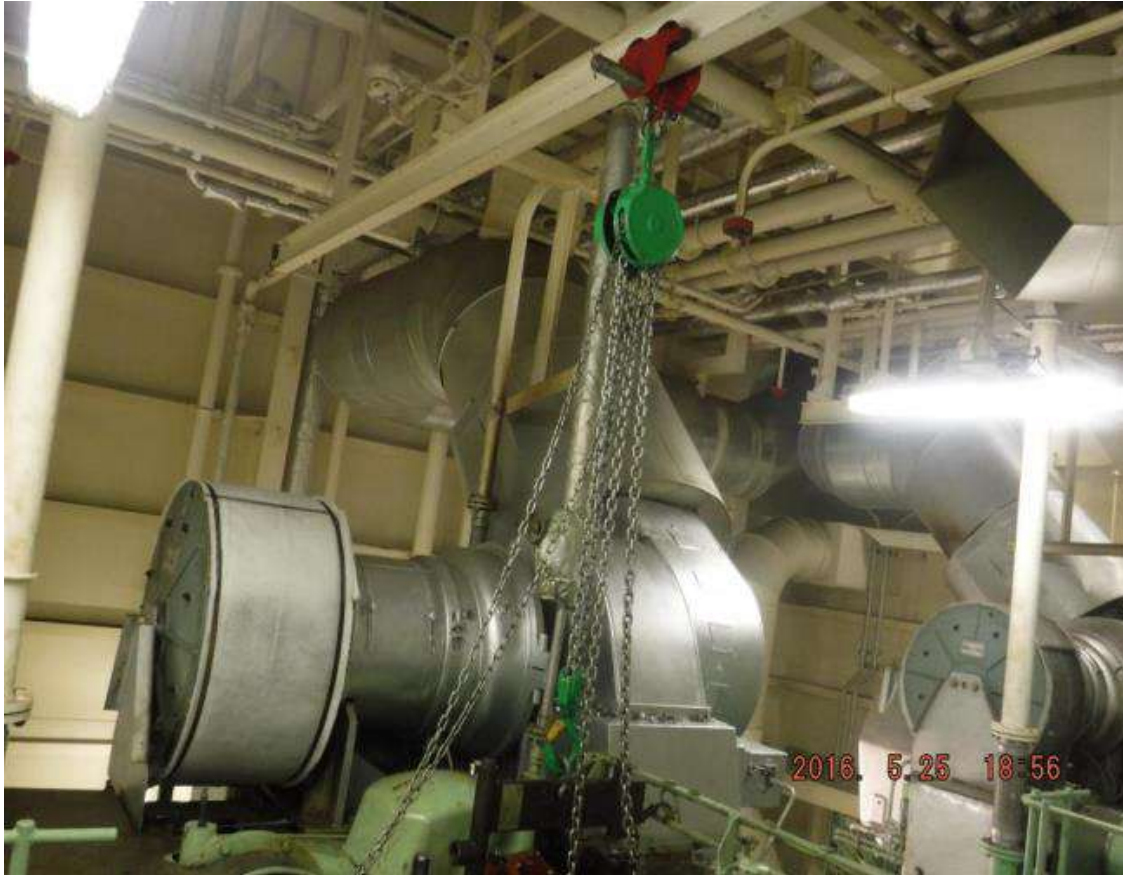
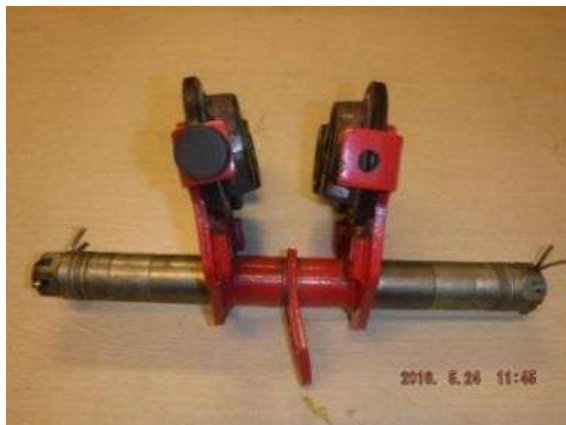
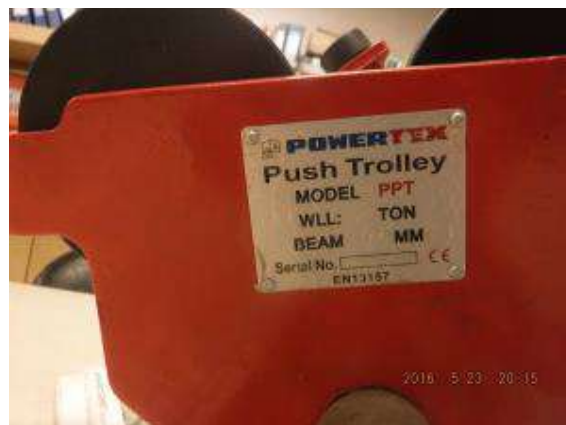
## **Serious injury as a result of mechanical failure**

IP sustained two broken bones in his hand when an I-Beam trolley failed and fell down hitting his hand. The investigation found the I-Beam trolley failed as a result of higher forces generated in the lifting arrangement by a stuck cylinder head.

- The maintenance task involved the lifting up of an auxiliary engine cylinder head for the renewing of leaking O-rings
- The work team consisted of three people, the IP and two others.
- A job package had been prepared complete with safe job analysis and Toolbox talk.
- All connections to the cylinder head were removed.
- The lifting arrangement consisted of the lifting tool, the chain block, the shackle, the I-beam trolley, and the I-Beam.
- The auxiliary engine had recorded 21000 running hours.
- During the lifting the cylinder head became stuck.
- After repeated heaving on the lifting chain during the lifting process, the trolley failed and fell down together with the chain block, bounced on the cylinder head and then hit the IP's hand.

- The immediate cause was the failure of the I-Beam trolley which subsequently became the weakest link in the lifting arrangement when forces were increased as a result of the stuck cylinder head.
- The root cause was the inappropriate choice of chain block. The 3t chain block provided the ability to exert greater forces on the lifting equipment. The cylinder head weighed 750kg and had a 1 ton chain block been used, the crew would not have been able to exert further pull when the cylinder head became stuck.

- An inadequate safe job analysis which did not identify the hazard of the increased force on lifting equipment that can be generated from a stuck load and the subsequent risk of one of the lifting components failing as a result.
- Inadequate Toolbox talk which was generic in nature and assumed familiarity with the lifting procedure.
- Failure of transfer of knowledge from a previous similar incident on same vessel when the I-Beam trolley deformed without falling.

- Vessel management are requested to inspect the condition of I-Beam trolleys in use in the Engine Room paying particular attention to the side plates to identify signs of deflection. Should there be any sign of deflection, the side plates are to be repaired (if possible), or the trolleys replaced.
- Vessels are requested to review the safe job analysis and Toolbox talks for this particular task to include the hazard of exceeding SWL of all lifting components and to implement the appropriate controls.

- As part of the review of the safe job analysis and Toolbox talk include, in the event of the cylinder head becoming stuck, a jack is to be used to release the cylinder head rather than continuing with the use of a pulley. Once released, the pulley can then be used to raise the cylinder head.

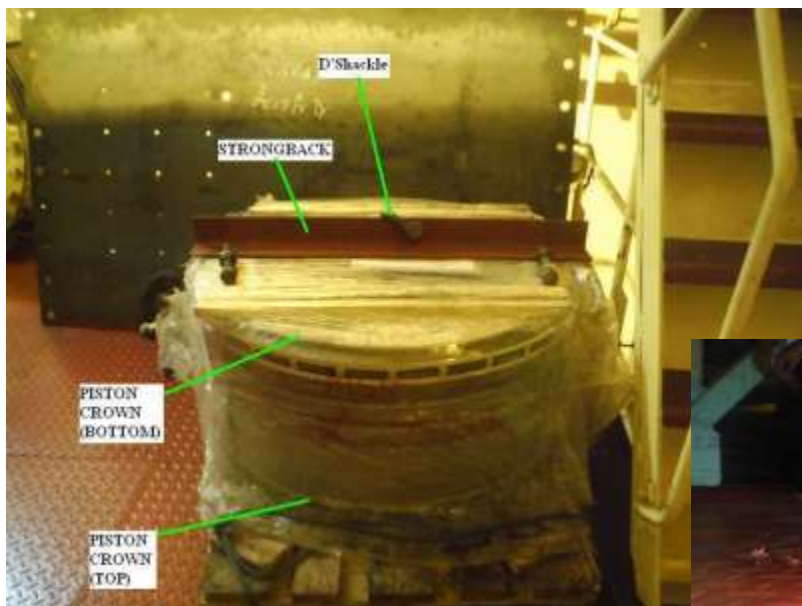
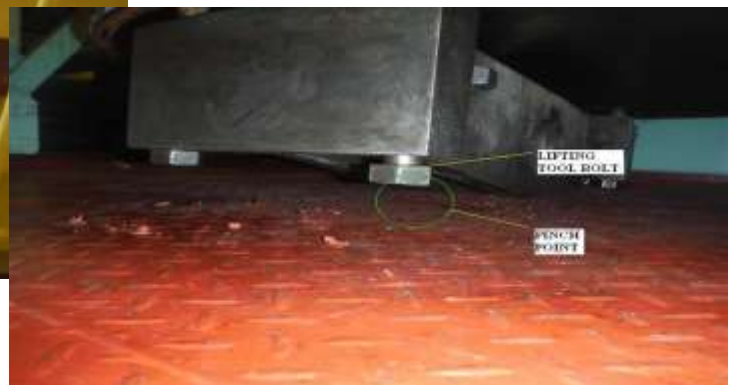
## Multi - Tasking

- Re-conditioned Piston crown received from workshop was stowed in an upside – down position.
- While turning crown around to lower onto the lifting gear – IP's finger got pinched between lifting gear & deck plate as the crown was lowered.
- IP suffered severe laceration & lost the tip of his right hand middle finger.

- Utilise team members efficiently & delegate tasks to maintain focus.
- Ask before operating cranes – ensure personnel are clear at safe working distance.
- Lifting points should be concentrated towards center of the weight for symmetrical balance.
- Use wooden blocks of sufficient height – it facilitates even weight distribution & eliminates pinch points.
- Avoid inadvertent operations - Activate 'STOP' on crane remote when not in use.

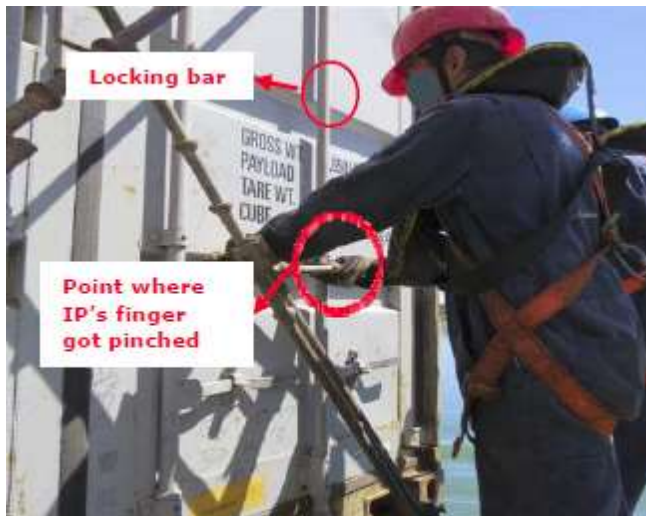
## Finger injury - Failure to follow instructions

- IP along with Person A were assigned the task of unlash outboard container during the river passage.
- Person A lost control of the long bar as soon as it came loose from the container socket.
- IP stepped in and caught the long bar to assist Person A in regaining control of bar and prevent from going overboard.
- As the long bar tilted further into horizontal position, the right hand ring-finger of the IP got crushed in between the long bar and a sharp edge of a container locking-bar. This resulted in a deep cut on his right hand ring-finger.
- IP was signed off from the pilot boat within 2 hours for treatment in hospital.

- Instructions not followed - Special instruction had been given during toolbox meeting to let go of the long bar in case of its uncontrolled movement. IP and Person A did not follow the instructions.
- Lack of situational awareness – IP instinctively stepped in to assist without realising the risks and failing to take notice of the pinch point.

- Execute the task by following the procedures and any special instructions.
- Stop and evaluate before putting your hands in the "line of fire".

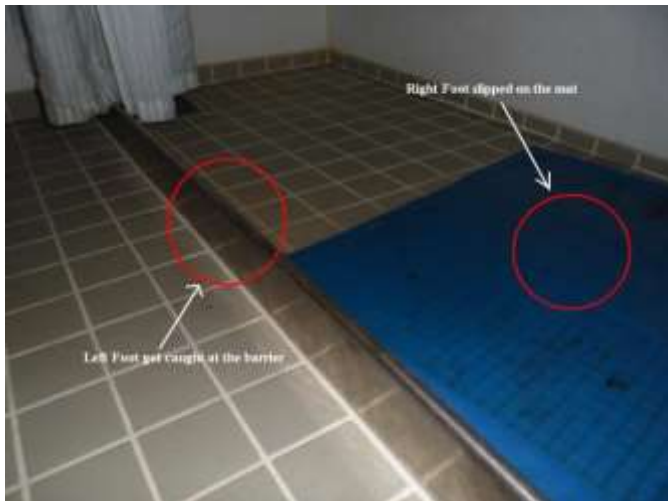
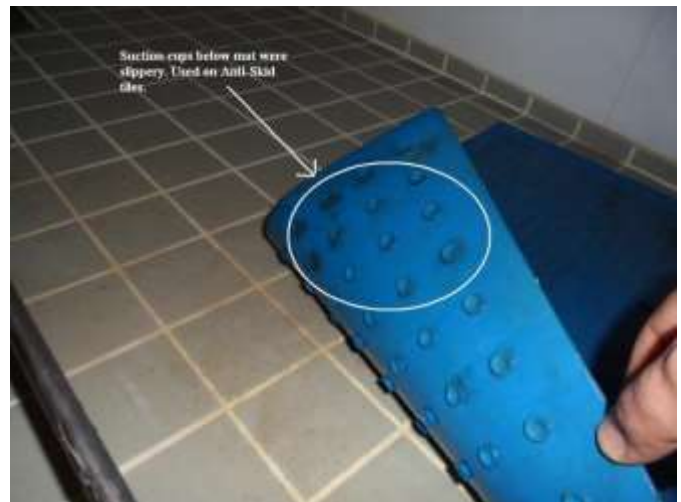
- IP was taking a shower.
- The tiling on the floor of the shower was of the anti-skid type. The shower mat had suction cups on the underside.
- As the IP turned in the shower, his right foot slipped on the shower mat, and his left foot got caught on the floor barrier.
- This caused severe pain and swelling in the left knee area to the point where the IP could not straighten his leg, or apply any pressure on the knee.
- The IP was required to sign off the vessel.

- All vessels to stop using shower mats in conjunction with anti-skid tiling in showers.
- All vessels to inspect their shower areas and remove and discard shower mats if used in shower areas with anti-skid tiling.

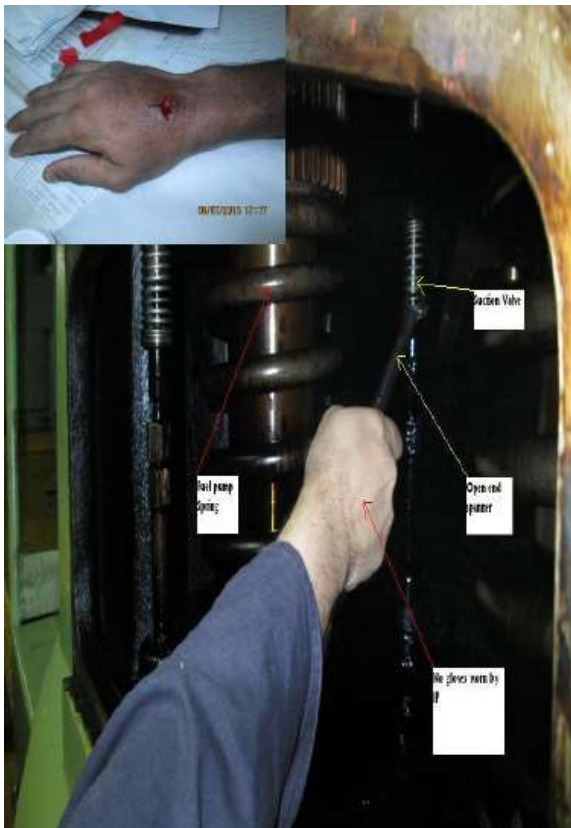
## Time Pressure

- During departure port, telegraph orders given by the Pilot were not reaching desired RPM. Investigation revealed ME exhaust gas temperatures for some units were not increasing as expected.
- Fuel pump suction valves were found to be seized.
- In an attempt to free the valve, IP used an open ended spanner which slipped and his hand hit the fuel pump moving spring.
- IP suffered a cut on his right hand – further medical evaluation revealed a fracture declaring IP unfit.

- Time pressure – due to vessel being under pilotage in restricted waters.
- Lapse of concentration – IP in a rush to avoid Main Engine shutdown lost focus.
- Failure to wear PPE – hand gloves.

- Keep calm & composed under pressure – to execute critical operations, Officer's capability to cope with stress & maintain focus is crucial.
- Wear appropriate PPE as required by the matrix.

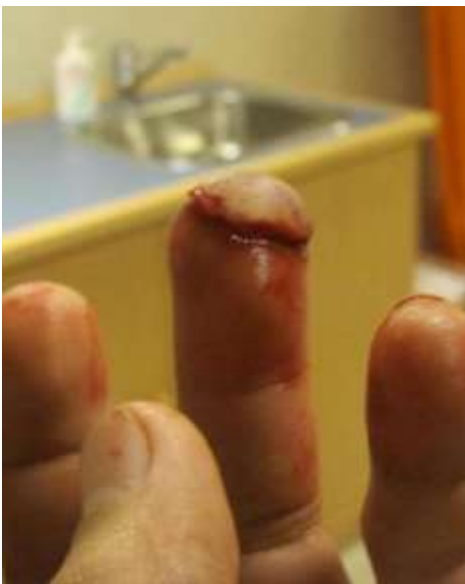
## **Hold the door open for the person behind you**

- Person A did not follow the basic safe practice to hold the door open for a person behind him.
- Please note air draught in engine room was not a cause in this incident.

- Hold the door open for the person behind you.
- Check settings of all door closers.
- Setting of the door closer has to be such that when a fire door closes on its own the sealing is proper to maintain the fire integrity. In this case the door closer was operational and setting was optimum to ensure sealing of the fire door. Optimal setting at times may be such that the door closes at a fast rate. Therefore it is important that in spite of a door closer, doors are opened and closed with care.

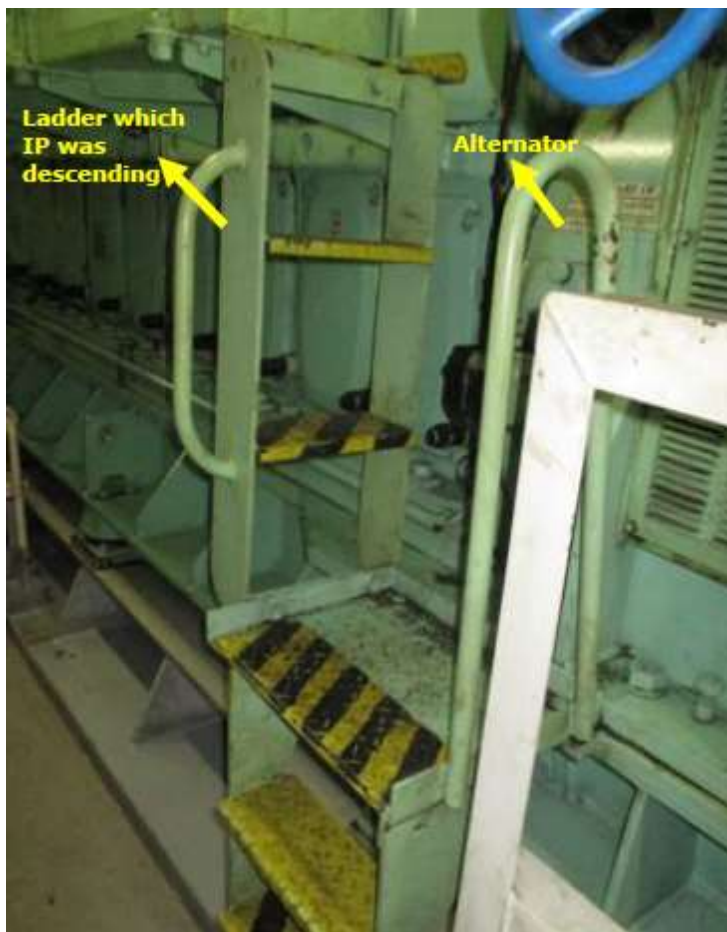
## **Improper pace while using ladder**

The picture reflects the actual area at the time of injury.

- Improper pace while using ladder – In an attempt to finish his work quickly, IP was keeping a hasty and rash body movement while descending down the ladder.

- Always focus and watch your steps while using ladders or stairs.
- Ensure proper rate of travel is maintained at all times.

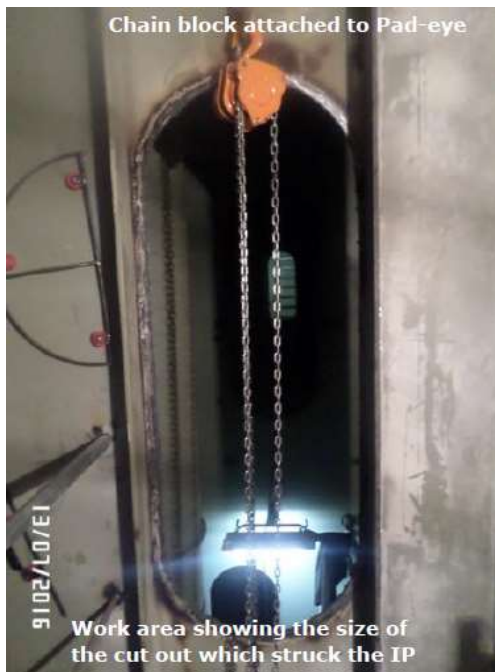
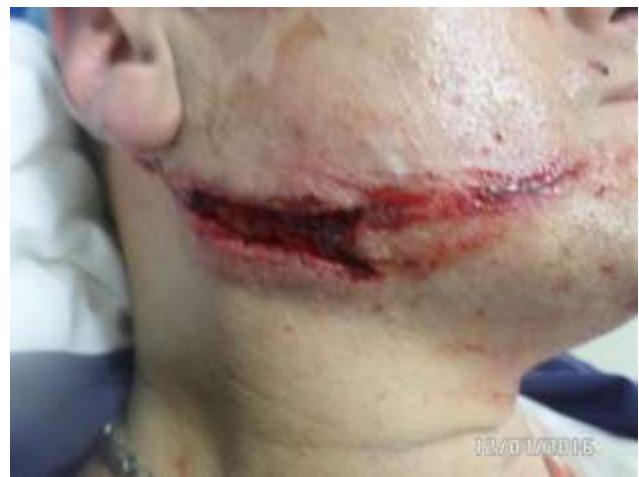
## **Facial Injury from being hit by a steel plate**

- The task involved cutting steel bulkhead in cargo hold for making an access as a part of the Reefer Expansion Project. Two persons from external repair team were engaged in the task.

- A Permit to work was issued, tool box meeting and risk assessment conducted and PPE worn.
- The steel plate intended to be cut-out was secured by a chain block to fabricated pad-eye on the bulkhead.

- Failure to identify the hazards, inadequate risk assessment applicable to the task and inadequate work processes.
- Possible over tightening of the chain block which created additional momentum to the swinging steel plate.
- Having only one point of securing of the chain block to the steel plate failed to prevent the steel plate from swinging on its own vertical or horizontal axis.

- Stop work was enforced on all vessels undergoing the reefer expansion project.
- Affected vessels were instructed to make repair team foreman as the safety representative with the primary responsibility to oversee that all tasks were being done safely, carry out site inspections daily and take a tool box talk with vessels management daily prior starting work.
- Work procedures and risk assessments from both contracting companies were obtained and reviewed ashore.
- Revised work instructions and risk assessments provided to all vessels undergoing the reefer expansion project for review and update of the safe job analysis and work instructions.
- Stop work was lifted once all reviews completed and the repair teams were instructed on the revised work instructions.

- Work procedures and risk assessments must be provided to vessels for all projects type work involving external repair teams prior to the team joining the vessels.
- Vessel-specific risk assessments must be prepared basis the work procedures and risk assessments provided.
- All work procedures and risk assessments to be discussed with the repair team and establish clear understanding of the work plan and safety responsibilities.
- Daily review of the work plan and tool box meeting with the repair team prior commencement of the task.

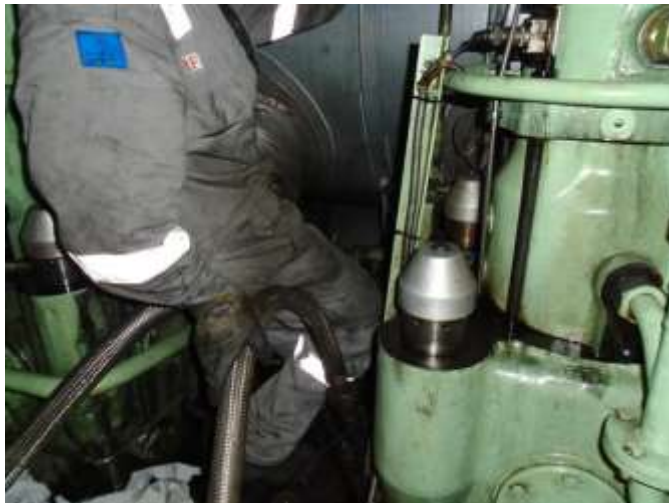
## **Burn injury by hot gases from the M/E bursting disc**

- Vessel was in maneuvering mode approaching pilot station. A leakage was noted on M/E Cylinder starting air valve. The leaking valve had to be replaced with a new one. To do that vessel decided to cancel pilot and head to anchorage in dead slow ahead.
- During maneuvering to anchor, an astern movement was given, which was immediately followed by the rupturing of all bursting discs causing hot exhaust gases to be released.
- Those gases hit the IP, who was at that moment standing on top of the cylinder head unit of the main engine. As a result, he suffered from 2nd degree burn injury to his right thigh.

- No toolbox talk was held prior starting the preparations and no risk assessment conducted.
- The senior engineer, did not confirm himself that the manoeuvring was finished and that the Main Starting air valve was closed and engine blocked from starting.
- Too many people in the working team – 4 persons in total. The space was very limited for 4 personnel to work there.
- Senior Engineer, who was responsible for the job, did not anticipate that there was a risk that the safety discs could break due to the leaking starting air valve. He should have isolated this unit prior further manoeuvring.
- Protection covers, when installed on the bursting discs, should direct gases towards the exhaust manifold and should be secured properly to withstand the pressure from gases. On several units the cover was broken off or improperly installed.

- Tool box is a crucial step before stating the task. It should never be dropped.
- Communication is vital for all activities. Supervisor should have coordinated and confirmed before going ahead with the planned task.
- Have the right amount of personnel who have been briefed thoroughly. More personnel with unclear instructions could lead to chaos.
- Unit of the engine should be isolated prior further manoeuvring in such cases.
- Engine maker has been approached for re-design of protective covers, which will effectively redirect gas flow towards the exhaust manifold in event of bursting disc rupture.

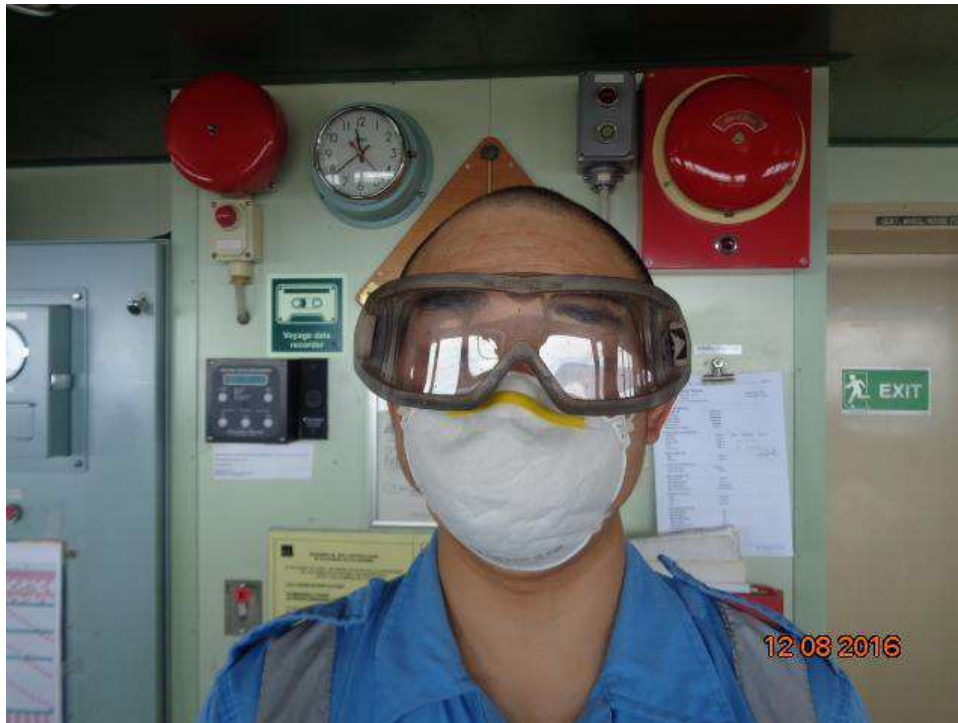
## Over-sized PPE

- During chipping on deck, foreign particle entered IP's eye.
- On-board attempts to remove the particle failed, following which Radio Medical advice was taken.
- Considering a long sea-passage & continued discomfort in IP's eye, vessel was deviated to the nearest Port.

- Use suitable PPE of appropriate size.
- Ensure sufficient pre-task checks – PPE alone does nothing to reduce the hazards, they should be adequately identified & addressed to ensure a safe working environment and working methods as safe as reasonably practical.

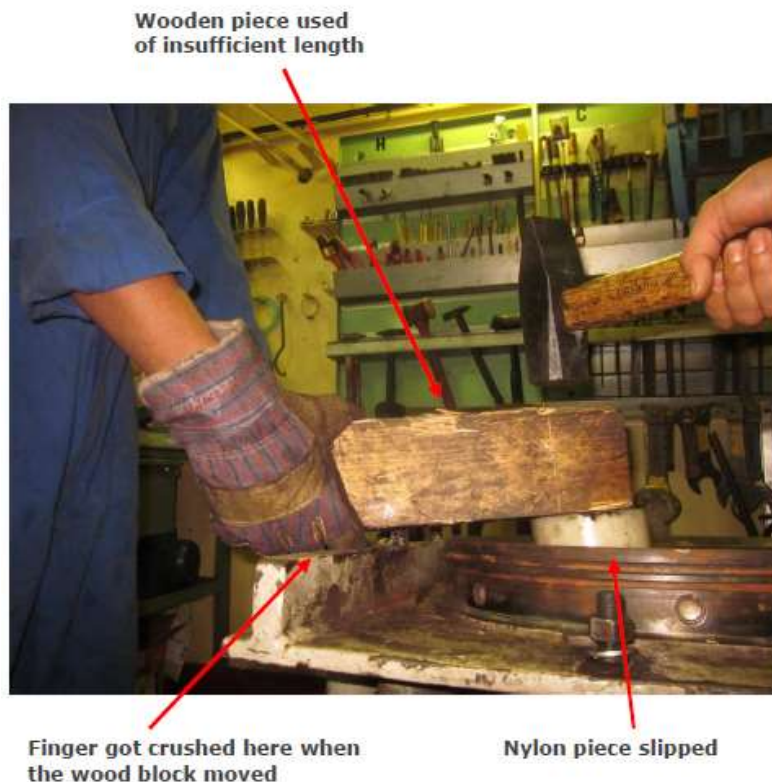
## **Incorrect tools and time pressure – a dangerous combination**

- Failure to identify the pinch point.
- Complacency and taking shortcut - The job had been in progress over the last 2 days after which the block and nylon rod broke. Thereafter the first readily available alternative was used without assessing the risks.
- Perceived time pressure – the seat pocket had been heated and the work team was in a hurry to get the seat in place before it cooled down.

- Stop use of homemade tools/systems. If it is necessary to use homemade tools, then these must be evaluated by the senior officers and engineers before being put into use.
- Do not execute jobs under time pressure. It is better to delay the job than risk an injury.

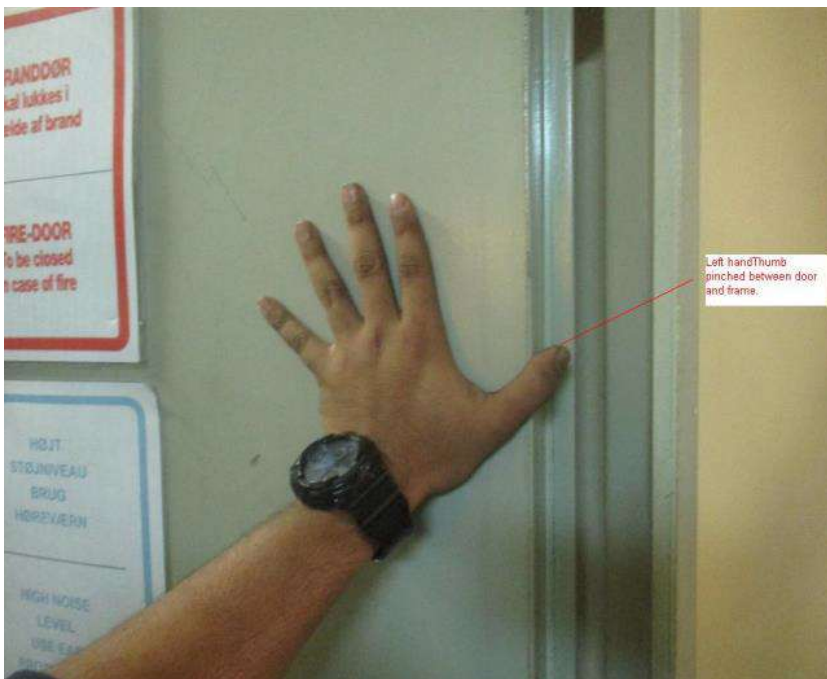
## Thumb injury in door frame

IP received a fracture to his thumb when passing through a doorway, requiring sign off from the vessel. He inadvertently placed and left his thumb in the door jamb when the door closed.

- Walking through doors on the vessel one of the many actions you will do as part of your daily tasks, whatever that task may be. Always consider each action you do when you execute that task.
- Focus on where you are putting your hands, focus on where you are putting your feet, and focus on where you walk.
- Use the door handle to open/close, or hold open the door.

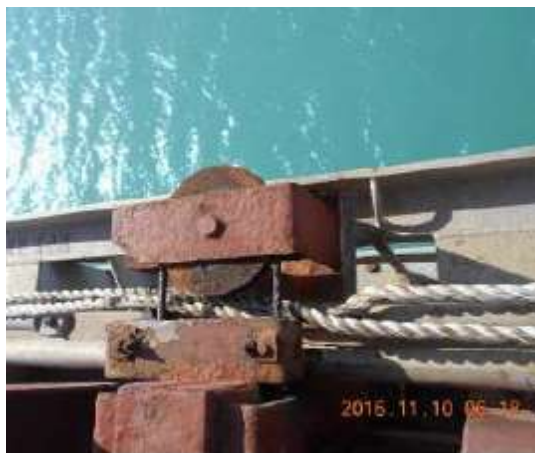
The sheave assembly where the wire jammed
