## **10 Types of Personal Injuries Seafarers Must Be Aware Of**

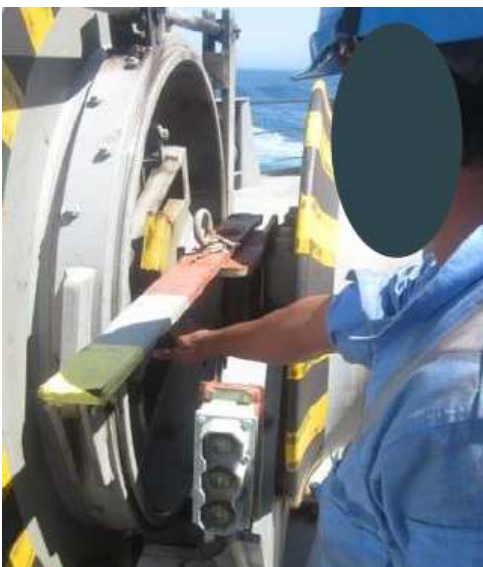
## Thumb Injury

Pictures are reconstructed however reflect the actual work area and how the incident happened.

- IP was putting twistlocks inside a box.
- While doing so one of the twistlock hit his left hand thumb causing fracture due to which he had to sign-off.

- While doing a job which involves throwing or swinging of objects do so by keeping the objects well clear of yourself and others working near you.
- Do not lose focus and attention even during a simple and routine job.

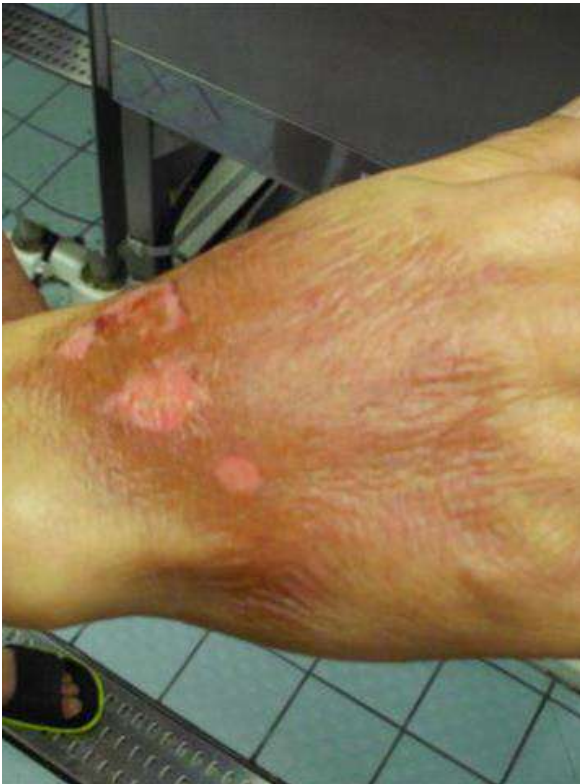
## Burn injury to fingers and arm of the right hand

- The task of repairing steam leaks was planned. There were leakages from the side flange and the top flange of the Aux boiler main stop valve. Gasket for these flanges were to be changed.
- All safety precautions were taken. Risk assessment was carried out, work permit issued, thorough tool box talk carried out and the necessary isolation was done before the job was commenced.
- While positioning the gasket, IP removed his gloves and put his hand inside the valve body which was still at a temperature of about 100 -120o Centigrade.
- As a result IP suffered burn injury to his fingers and part of his arm.

- IP did not use the already prepared gasket with tail – failure to follow the agreed work plan and use the correct equipment.
- Removal of the essential PPE.
- Failure to anticipate temperature of the surroundings.

- Do not remove PPE when working on hot surfaces. PPE is the FINAL guard against any hazards and removing these guards exposes the body to injuries.
- All tasks must be done according to the work plan and using the agreed equipment.
- Always work on hot systems (water, steam, fuel) with extreme caution – even when all the isolations are done.

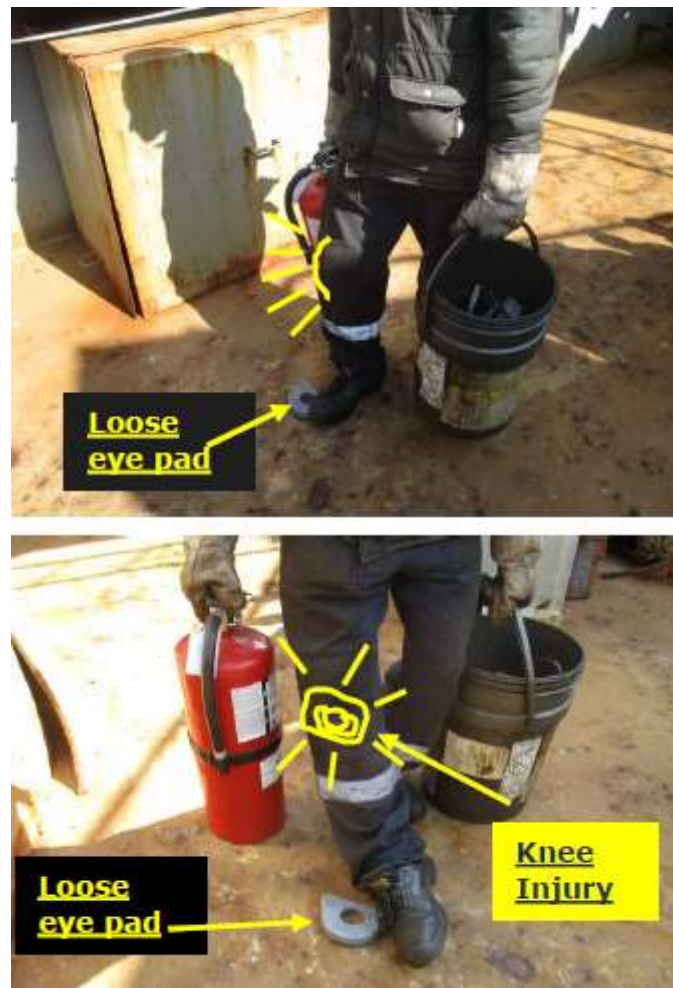
## Strained Knee

Musculoskeletal Disorders (MSD) can affect muscles, nerves, tendons, ligaments, joints, cartilage and spinal discs. MSD are often related to job duties or the work environment. Risk factors include high task repetition, forceful exertions and working in awkward postures as well as an individual's fitness and overall health.

- Stop immediately if you feel discomfort when making certain motions.
- Ask for a professional medical evaluation if the discomfort persists. Do not wait for the pain to take hold before reporting a potential MSD injury.
- Focus on your long-term health at home and at work.
- Execute work in a manner that minimizes your exposure to MSD risk factors.

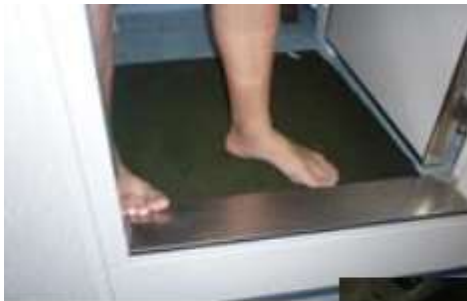
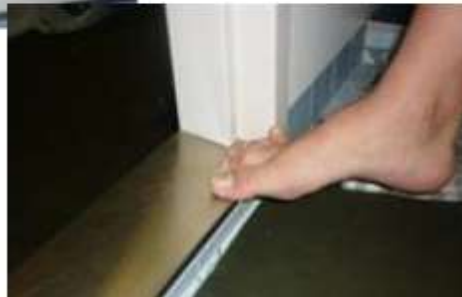
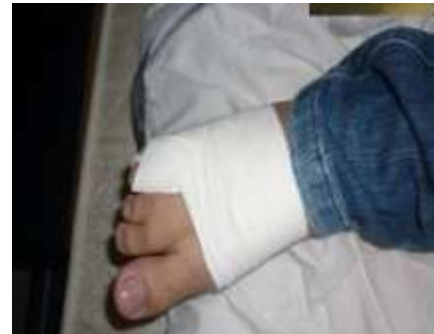
- Vessel berthed at port and after mooring operations, IP was sent off duty for rest.
- He took bath and was coming out of his bathroom. While stepping out, he hit his foot against the door frame causing an injury to his fifth toe.
- He was sent ashore to the doctor, where it was confirmed that IP suffered a fracture and needed rest for 15 days.
- Subsequently, IP was signed off the vessel.

- Do not rush yourself into the next activity. Injury retards the process further. Do not take that risk. Medical assistance is limited on the vessel. This has to be always kept in mind.
- Whether it is a ship's task or your personal job, assessing risk is extremely important to avoid injuries. Safety cannot be looked at in isolation.

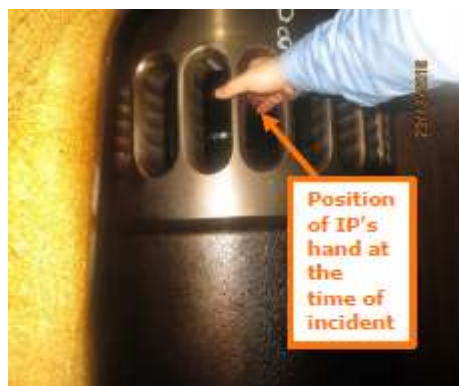
## Hand injury – Incorrect execution of task

- Failure to execute the task correctly. The turning gear remote was being operated by Person A who had no visibility of the actual movement of piston or sight of IP's activity inside the scavenge receiver.
- Failure to stop and take stock of the situation. Despite knowing that piston was moving, IP continued to keep his hand inside the scavenge port.
- Lack of risk assessment- No risk assessment was done prior starting the job.

- Turning Gear remote is designed to be carried inside the scavenge receiver for inspection. For safety reasons, it should only be controlled/operated by the person carrying out inspection.
- Vessels to review their risk assessments for scavenge space inspections and ensure that the safe practice of using turning gear remote is clearly written.
- Ensure that usage of turning gear remote is also talked about in meetings and clearly understood by the work team who is going to handle it, in addition to the responsibilities of stand-by person outside the scavenge space.

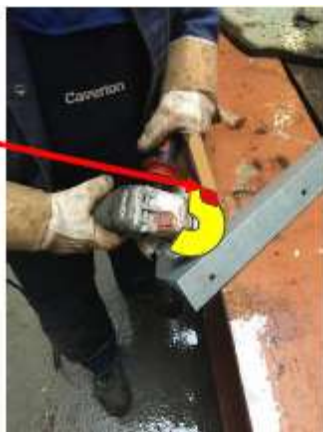
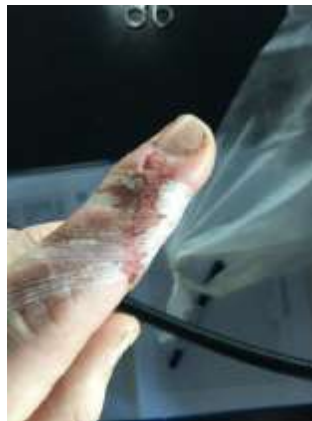
- IP was rushing to complete the task and hence lowered the safety guard.
- Inadequate supervision.

Finger point of  
contact with  
the disc

- Stop and evaluate the risk associated with all the jobs. The entire team was rushing to complete the task assigned to them within a stipulated period by taking shortcut on the safety requirements.
- Focus on the task at hand. Rotating machinery has dangers associated.

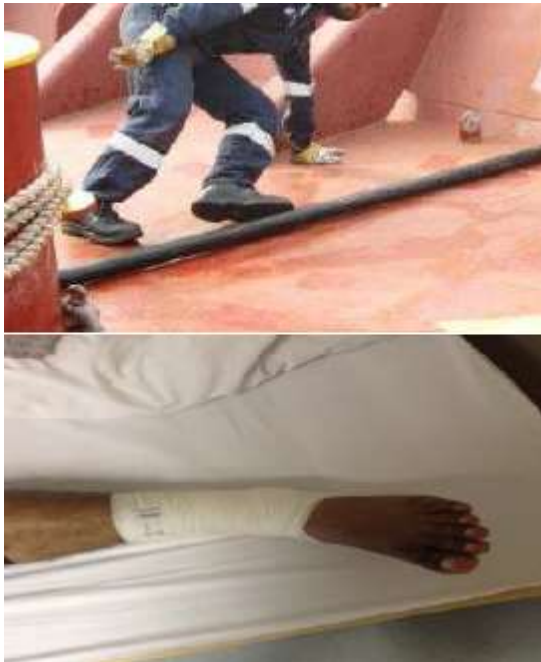
## **Leg/ankle sprain injury by stepping over the pipe**

- IP was returning from work for lunch has stepped up the pipe lying on the forecastle deck, which caused him ankle twist and sprain on left leg.
- There was no impact or fall which resulted in the injury.
- Onboard pain killer was administered and ankle was bandaged, which has subsided the swelling to local area only and reduced the pain/level of discomfort.
- IP resumed normal duties after 2 days as there was only localized swelling and less pain.
- Vessel reached port after 12 days and IP was sent ashore for proper examination where doctor has declared him unfit for 3 weeks and advised him bandage and medication.
- A week after that, IP again complained of pain and discomfort, to which Captain took radio medical advice which is when Captain decided to sign him off from vessel for better diagnostic and treatment.

- Lack of situational awareness which prompted IP to step over the pipe despite having enough clear space to pass.
- An unsafe act of putting the pipe flat on deck for the purpose unknown.

- Stop to ensure no obstruction/loose items to safe passage on deck.
- Act immediately in case any hazards is noticed. Report or remove as required.
- Focus on your personal safety. It is not always things which look routine are harmless.
- Execute precautions to prevent any accident/incident.

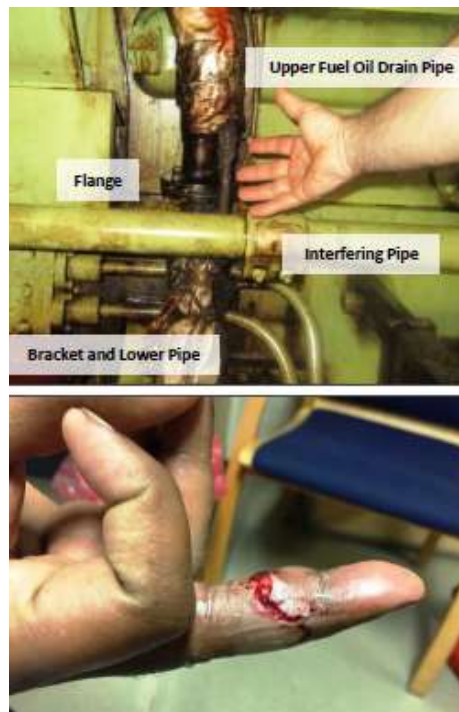
## Planning for Safety

- IP unbolted the flange and removed the bracket that held the lower pipe in place. However, the lower pipe would not move. IP attempted to loosen the stuck lower pipe by reaching over a horizontal interfering pipe and grabbing its flange with both hands. At this point the lower pipe came free and its weight pulled the IP's hands down sharply.

- IP's middle finger was caught between the falling pipe and the lower bracket mount, resulting in the injury depicted in the photograph. IP was not wearing protective gloves when this incident occurred.

- Seek assistance when lifting around interferences such as pipes, conduits or ducts; especially in instances where crewmembers must crawl over or under obstacles or work in awkward positions.
- Always wear protective gloves when performing mechanical and manual lifts.
- Focus on your safety at all times. Maintain awareness of hand and body placement and location of pinch points.
- Expect a better outcome by identifying potential problems and interferences before the work begins. Develop a plan to avoid those problems.

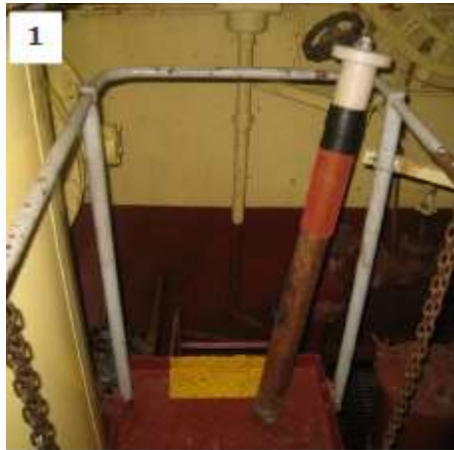
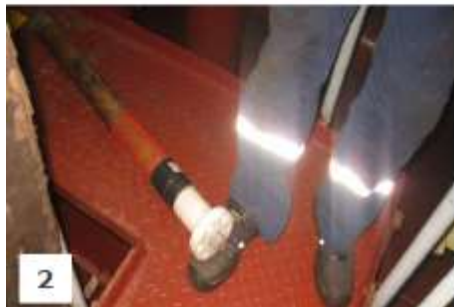
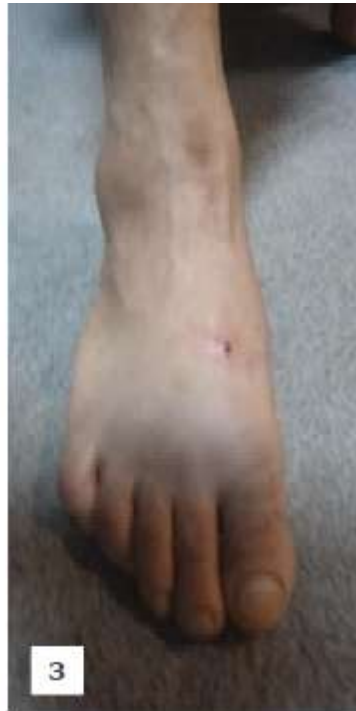
## Foot injury due to spare part not secured

- During inspection/cleaning of sea chest one of the anode required replacement.
- Old anode was removed and new electrode was brought near the site and kept in a vertical position resting on the railing as shown in picture 1.
- Person A while climbing up the ladder accidentally touched the anode and it fell on the IP's foot resulting in fracture. Refer picture 2 & 3.
- IP was standing-by for assistance if needed.

- No risk assessment was done, left spare anode standing without securing.
- Inadequate supervision.
- Zero situational awareness.

- Stop and assess the work place for hazards.
- Risk assessments for any task should also consider loose lying items – tools, spares etc. and the hazards they pose.

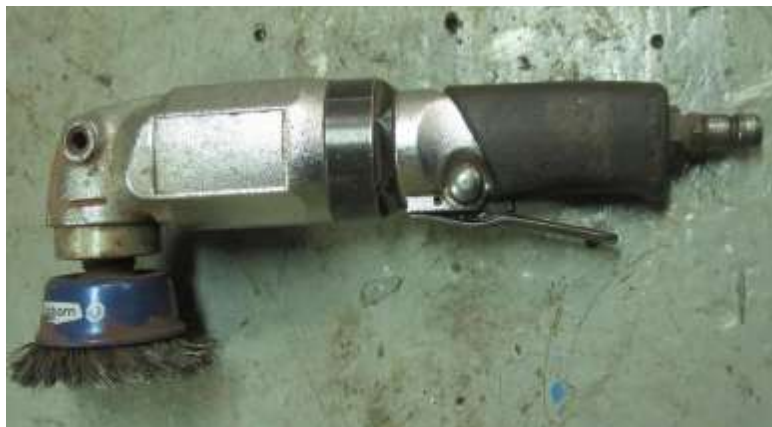
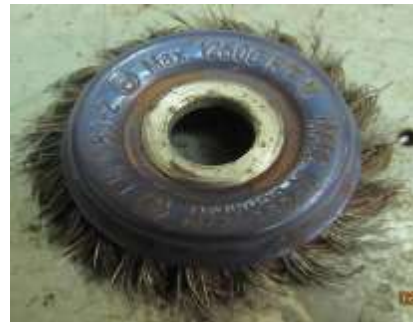
## **Injury while using cup wire brush**

- Poor condition of work equipment - cup wire brush was over used, wire strands loose.
- Inadequate supervision – As a responsible person, supervisor should have checked the right tool/condition of tool being used.

- Stop using a damaged/overused equipment – Make sure no damaged/overused equipment are used onboard.
- Focus on personal safety – We should understand that right personal protective equipment as well as right tools for the task is important for a safe job.
- Commence the job only when all checks are complete.

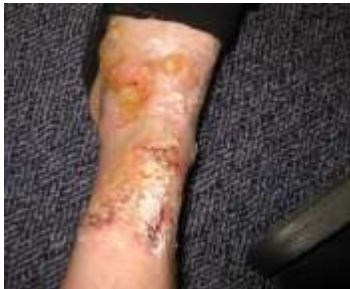
# Chemical Burns

- Incorrect way to prepare a caustic cleaning solution by mixing caustic soda with fresh water in a plastic drum.
- Caustic cleaners should be added directly to the tank in a manner that minimize exposure to the crew.
- Movement of the vessel combined with the improper handling of an open drum caused the solution to spill onto the deck.

- Tank cleaning chemicals are to be used in accordance with manufacturer and industry guidelines.
- A proper risk assessment is to be conducted prior to using chemicals and tank cleaning.
